# PAWTUXET RIVER BASIN SCITUATE, RHODE ISLAND

# MOSWANSICUT POND DAM RI 03002

PHASE 1 INSPECTION REPORT
NATIONAL DAM INSPECTION PROGRAM

OCTOBER, 1980

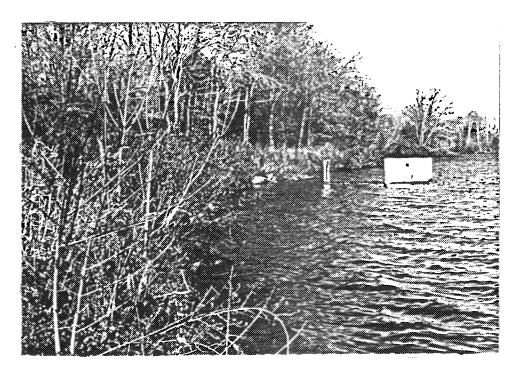
. PHOTO C-1 UPSTREAM FACE OF DAM LOOKING TOWARD RIGHT ABUTMENT

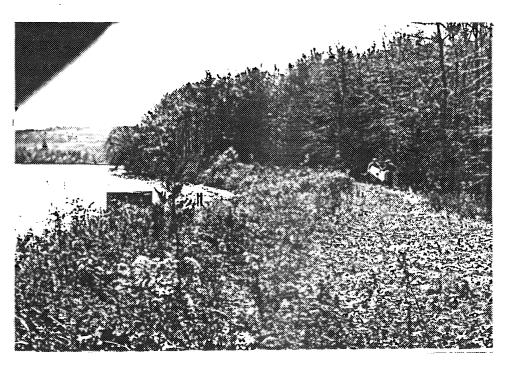
PHOTO C-2 UPSTREAM FACE AND CREST OF DAM LOOKING TOWARD LEFT ABUTMENT

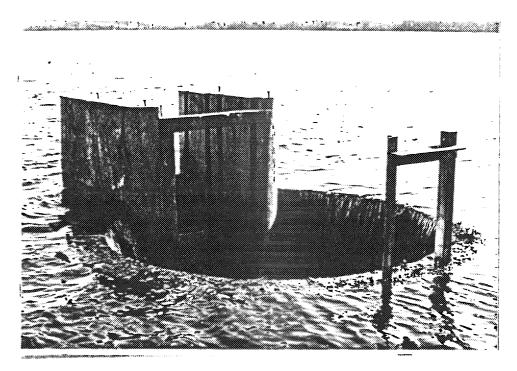
- b. Description of Dam and Appurtenances The dam at Moswansicut Pond is approximately 450 feet long, and is assumed to be a homogeneous earth embankment structure about 15 feet high. It is unknown if the embankment contains a corewall or cutoff. The embankment has slopes that vary, but are typically 2H on 1V for both upstream and downstream faces and has a crest width of 15 feet. The overflow spillway is an uncontrolled reinforced circular concrete drop inlet 12 feet in diameter. Spillway crests elevation is 304.20 feet NGVD. Discharges flow over the circular spillway crest dropping about 10 feet to a 5'6" W by 8'0" H arched conduit that carries

PHOTO C-4 OVERFLOW DROP INLET SPILLWAY (STRUCTURE ALSO CONTAINS STOPLOG CONTROLLED OUTLET WORKS).

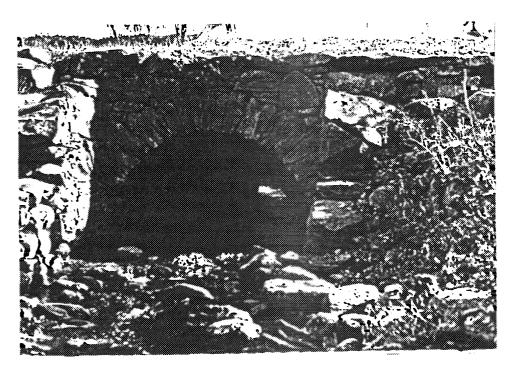
the flow through the embankment and downstream. (See Photo C-4). An emergency spillway is located north of the embankment approximately 1,500 feet and is controlled by a 42-inch diameter concrete culvert. This emergency spillway permits reservoir stages above elevation 305.7 feet (1.5 feet above the overflow spillway crest) to flow through a natural stream bed around the dam and downstream. The outlet works for the Pond is incorporated into the overflow spillway structure and is a rectangular opening, controlled by stop logs placed in guide channels in the sidewalls. Discharges flow through the spillway conduit to the downstream channel. (See Photo C-5).

. PHOTO C-5 OUTLET COMDUIT THROUGH DAM FOR SPILLWAY STRUCTURE

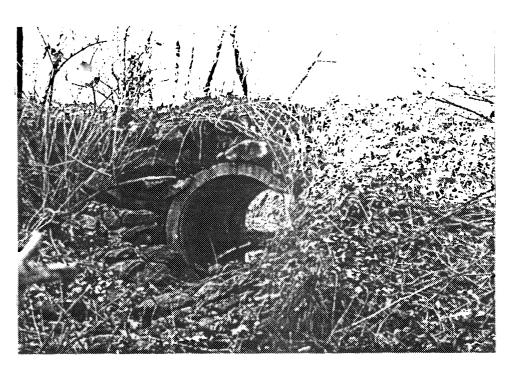
PHOTO C-6 EMERGENCY OVERFLOW SPILLWAY NORTH OF MAIN DAM

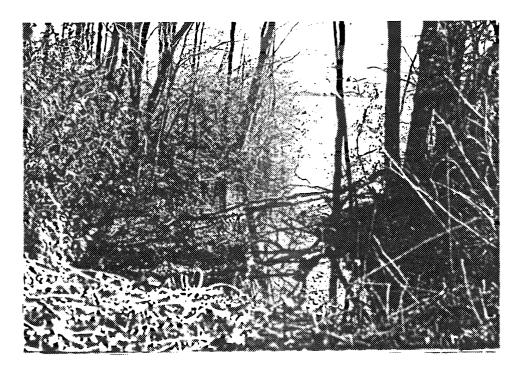
PHOTO C-7 APPROACH CHANNEL FOR EMERGENCY SPILLWAY

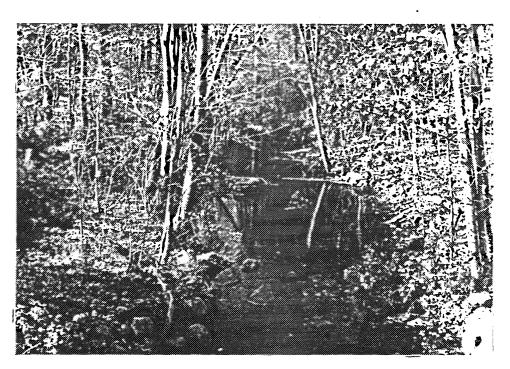
PHOTO C-8 DOWNSTREAM CHANNEL

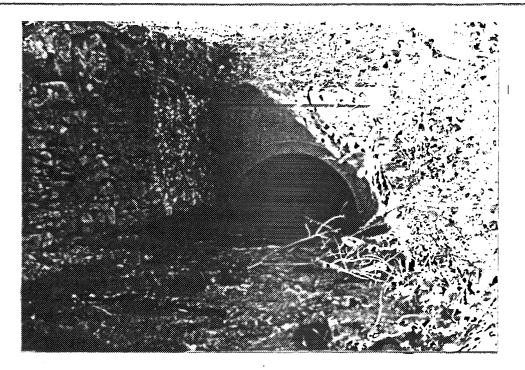
PHOTO C-9 HIGHWAY CULVERT UNDER ROUTE 116
